Test with a fire blanket on a burning vehicle

Bridgehill Car Fire Blanket Standard 2

## Test with a fire blanket on a burning vehicle

PROJECT NO.	0535-25BRM
REPORT NO.	0535-25BRM-B
REPORT ISSUED BY	RISE Fire Research AS <i>(hereinafter referred to as RISE)</i>
DATE OF ISSUE	2025-11-12
SPONSOR	Bridgehill AS Elveveien 34 3262 Larvik Norway
SPONSOR'S REF.	Thomas Jahren
NO. PAGES INCL. APPENDICES	16
STANDARD/METHOD	Non-standardized Bespoke / Ad-Hoc
PRODUCT/SPECIMEN	Bridgehill Car Fire Blanket Standard 2
TEST SPECIMEN RECEIVED	2025-08-27
DATE OF TEST	2025-09-10
TEST LOCATION	RISE Fire Research AS Tillerbruvegen 202 NO-7092 Tiller Norway
PURPOSE OF TEST	Informational purpose / Research and development purpose
AUTHOR OF REPORT	Petter Eide, Test Engineer  
QUALITY ASSURANCE	Tian Li, Research Manager

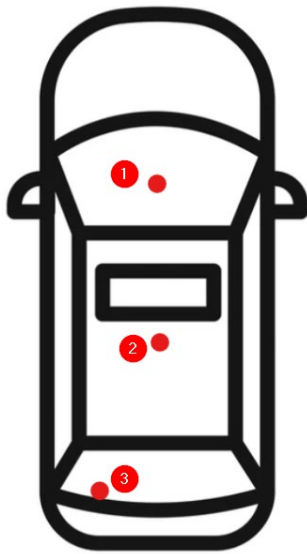
Figure 1 Position of thermocouples. The figure is for information only and is not to scale and not representative for the vehicle used during the tests.

Shielded thermocouples, type K, were installed to measure the temperature in different positions of the vehicles. These were used to monitor the temperature of the vehicles and to use as an indicator for when to apply the blankets to the vehicles and when to remove them. Positions are also given in Table 2 and Figure 1.

Table 2 Positions of the thermocouples for temperature measurements.

ID no.	Position
1	Inside the vehicle, around the gear stick.
2	In the centre top of the vehicle, approximately 2 cm underneath the roof.
3	Inside the vehicle, towards the trunk.

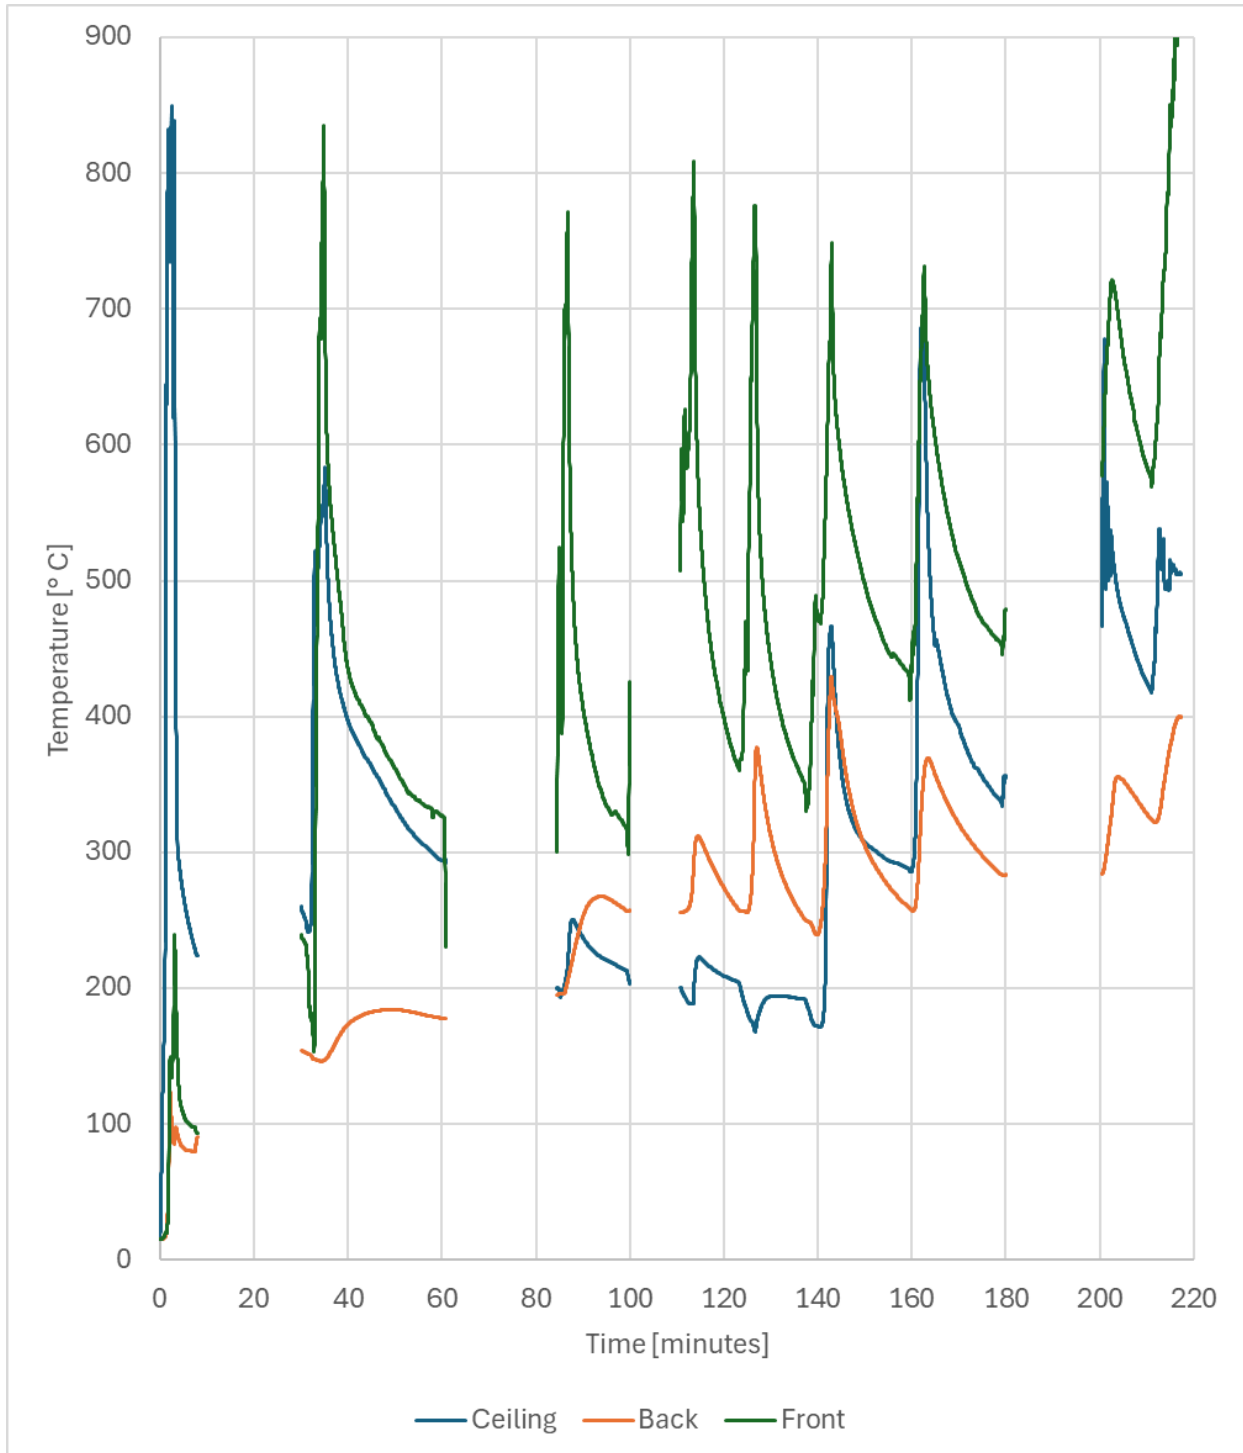
Figure 2 Temperature measurements inside the vehicle during the test series. Gaps in the measurements indicate testing with the Single use blanket, and these measurements are removed from the figure. The peaks represent the maximum measured temperature inside the vehicle before applying the blanket. The exact start and end times of each test are difficult to specify and may not be accurately represented in the figure.

Temperature measurements inside the vehicle are given in Appendix A.

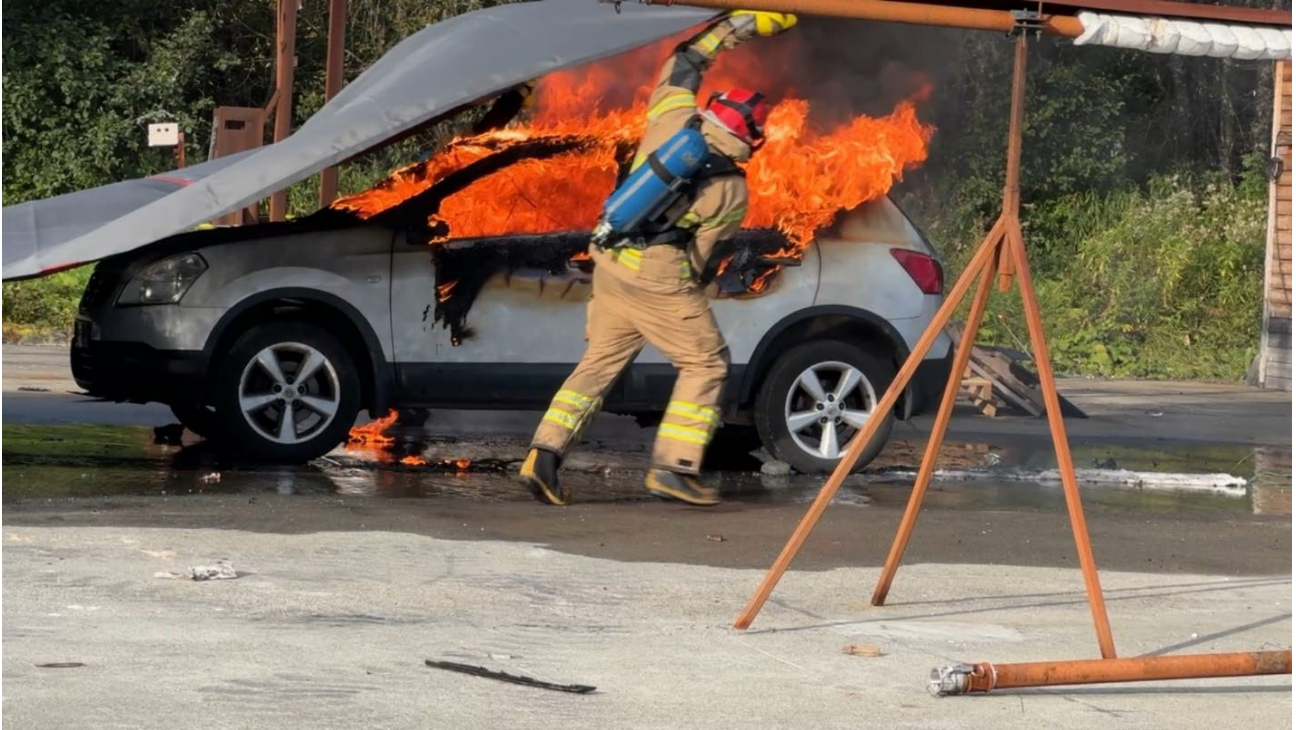
Photo 1 Blanket being pulled over the vehicle.

The test was initiated by igniting a zip-lock bag with a mixture of diesel and heptane, which was placed inside the vehicle. After the vehicle was set on fire, the temperatures were monitored. After the temperature at the top of the vehicle, detailed in section 3.2, reached approximately 800 °C, the blanket was pulled over the vehicle after instructions given by the sponsor. This was done by pulling the loops on two corners facing the vehicle and lifting it as high and firmly as possible so that the blanket managed to cover the entire vehicle. The two people doing this were fully equipped with firefighting gear.

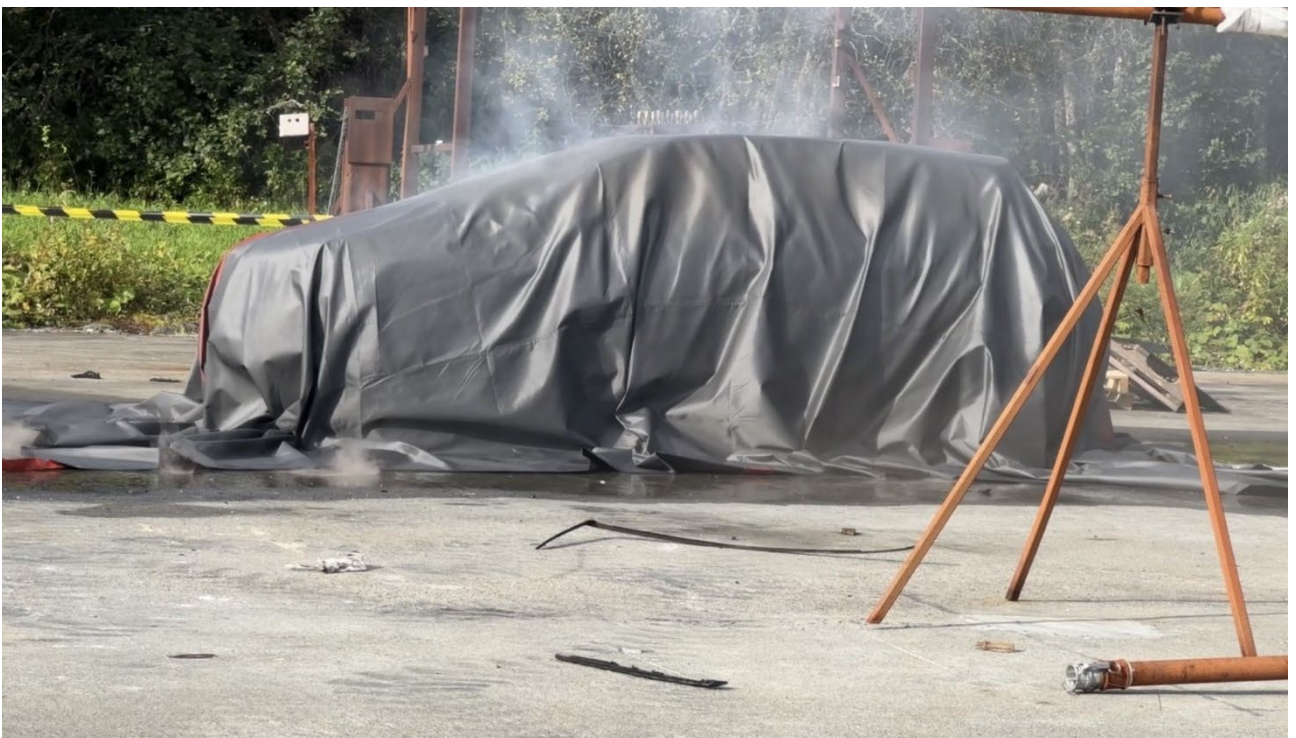
Photo 2 Blanket placed over the vehicle.

After the blanket had covered the vehicle, it was wrapped around the vehicle using the feet to move the blanket closer to the vehicle near the ground.

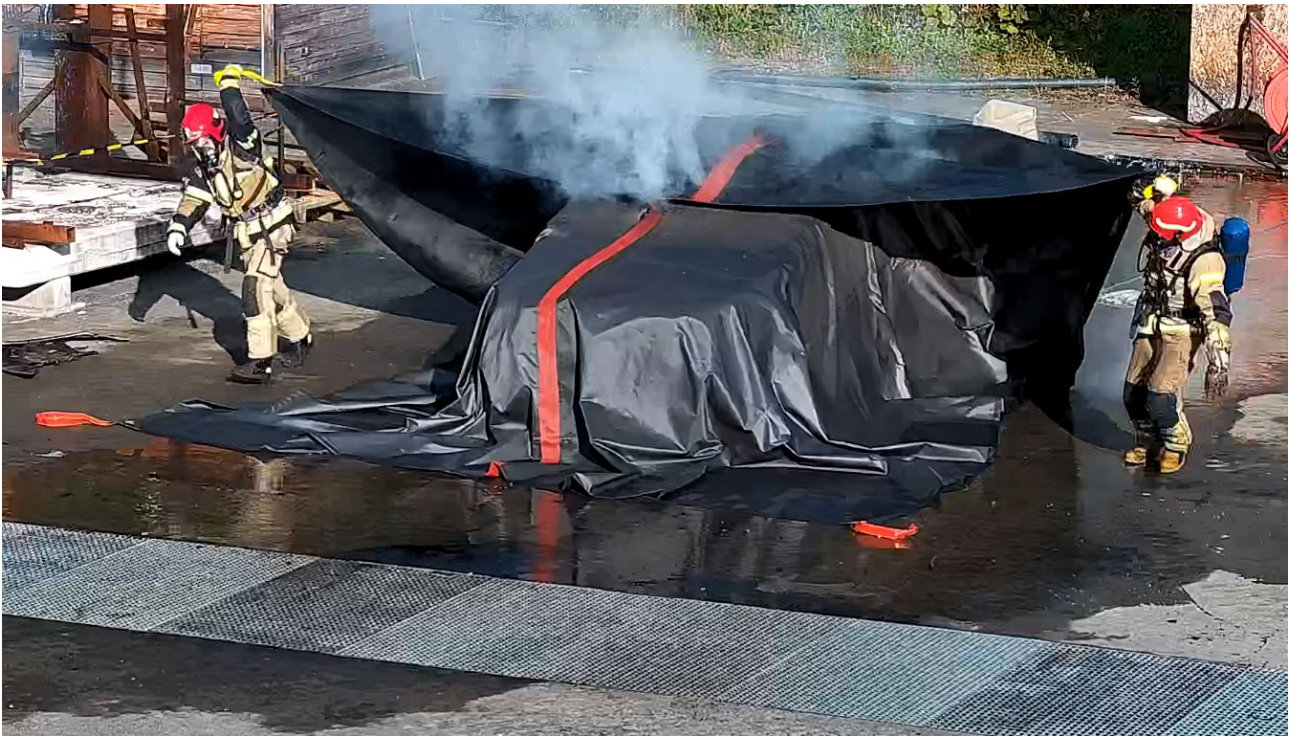
Photo 3 Blanket being removed from the vehicle.

After the temperature had dropped to around 300 °C – 400 °C, measured in the ceiling at the top of the vehicle, the blanket was removed. The blanket was removed by pulling the loops in the opposite direction of the blanket and pulling it back to the starting position. The blanket was then folded as it was initially done, and placed in the same position as before pulling the blanket over the vehicle.

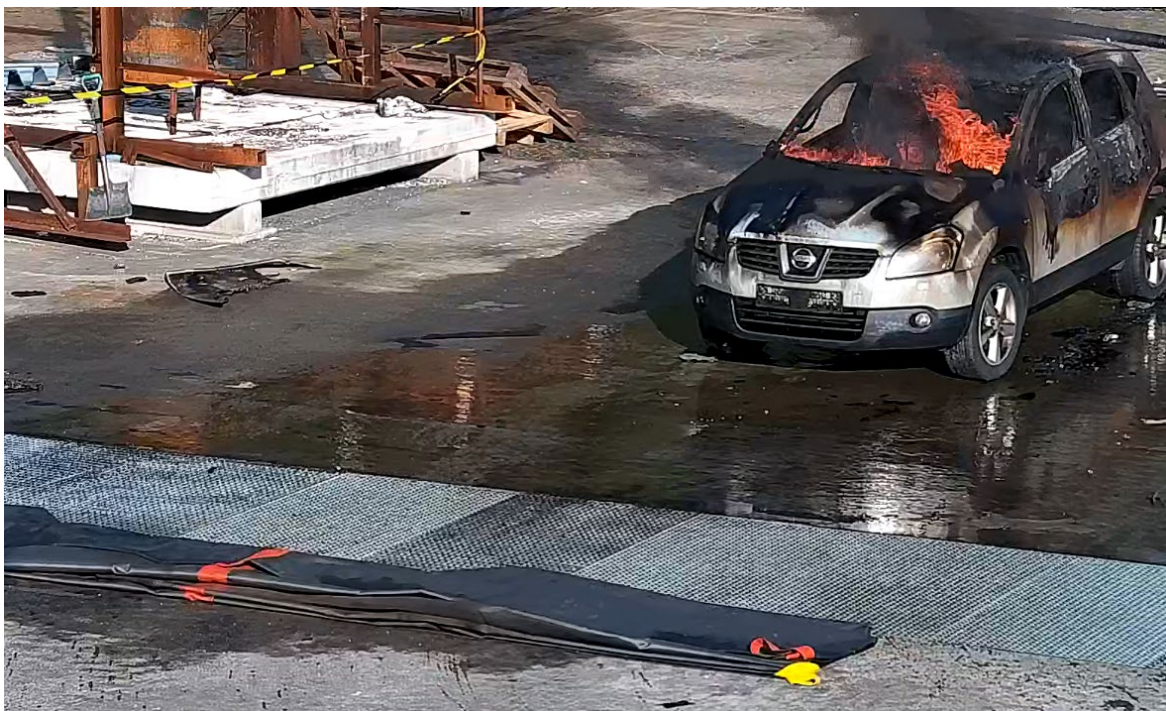
Photo 4 Blanket has been folded in layers in front of the vehicle and is ready for a new test.

A blanket was placed approximately 5 meters in front of the vehicle. The blanket was folded a couple of times according to instructions given by the sponsor to allow for easier handling of the blanket. The ground was continuously cooled with water from a water sprinkling device during the test series.

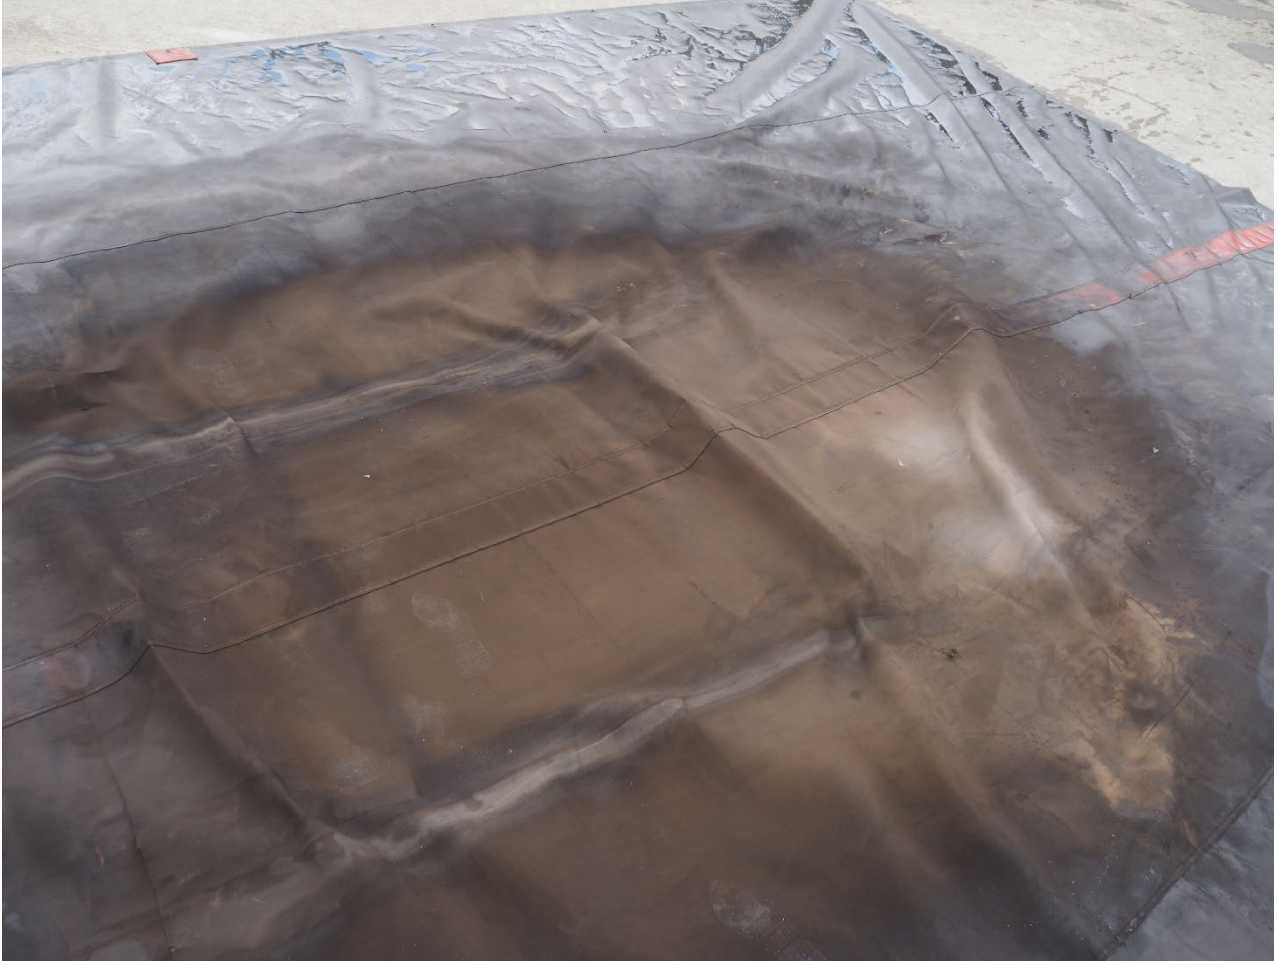
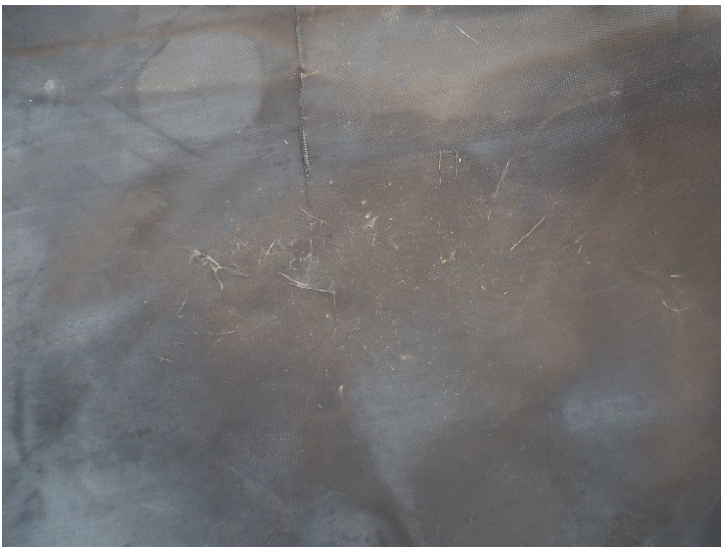
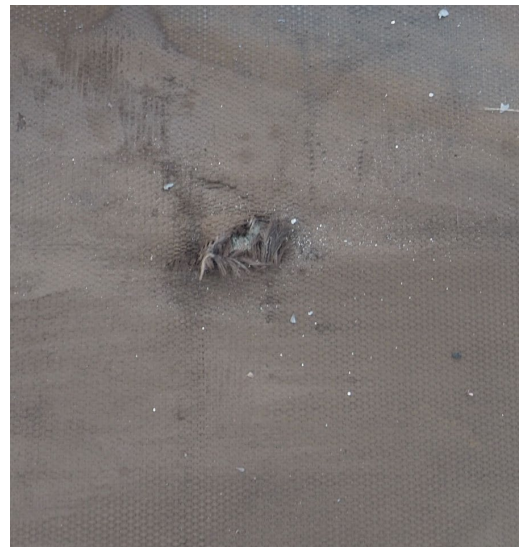
*Photo 5 Photos of the Bridgehill Standard 2 blanket after the end of the test series.*

The *Bridgehill Car Fire Blanket Standard 2* was tested on a vehicle which was set on fire. The Blanket was pulled over the vehicle 8 times as planned, with an average fire exposure time of 13 minutes. The blanket had a few rifts after the test series.

The centre part of the blanket was more discoloured and felt stiffer than the outer parts of the blanket after the whole test series.

02:43	Pulling the blanket over the vehicle (7).
02:59	Removing the blanket.
03:22	Pulling the blanket over the vehicle (8).
03:33	Removing the blanket.
03:33	<b>The end of the fire test is at the request of the sponsor.</b> The test is terminated due to time constraints and because the number of tests planned has been performed. Directly after the end of the test the blankets are inspected. The centre part of the blanket is more discoloured and feels stiffer than the outer parts of the blanket after the whole test campaign. Some rifts in the blanket are observed.
